CALSPAN ON-SITE AMBULANCE CRASH INVESTIGATION

SCI CASE NO.: CA12002

VEHICLE: 2012 FORD ECONOLINE 350 / MEDIX TYPE II AMBULANCE

CRASH DATE: JANUARY 2012

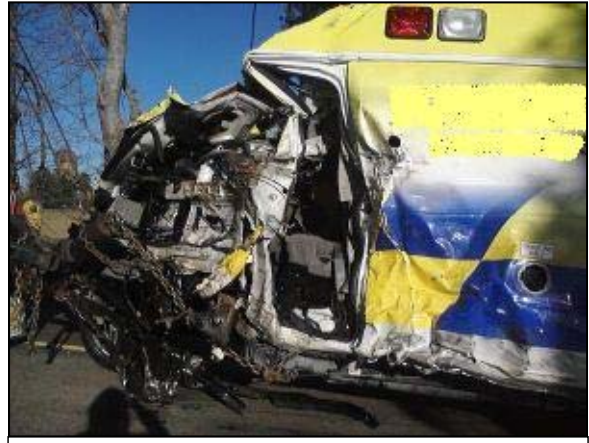
Figure 1: On-scene image of the involved ambulance (*obtained from an online news source*).

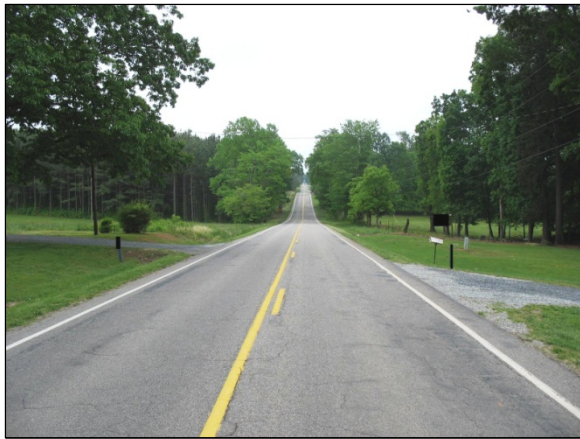
Figure 2: Southbound trajectory view of the ambulance's travel path.

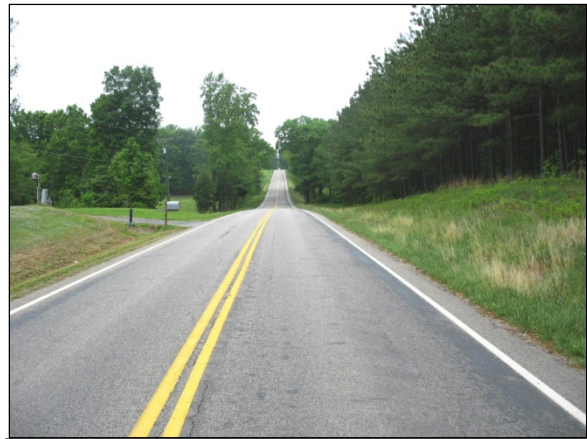
Figure 3: Northbound trajectory view of the Kenworth's travel path.

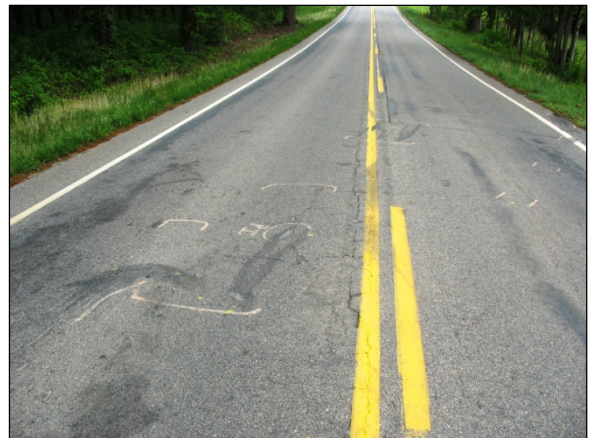
The Kenworth truck traveled northbound on the rural roadway, crested a hill, and began its descent. The 29-year-old male driver of the Kenworth observed the ambulance traveling southbound descending the opposing hill, and recognized its encroachment into the northbound lane as it crossed the centerline. In response, the driver of the Kenworth initiated avoidance braking with a right steering input in an attempt to avoid a collision as the frontal plane of the ambulance approached the frontal plane of the Kenworth. Avoidance action by the Kenworth was evidenced by the off-center point of impact and its' location within the roadway (**Figure 4**). There was no evidence at the scene to support avoidance action by the driver of the ambulance.

Figure 4: Southward trajectory view of the point of initial impact.

The first crash event occurred as the frontal plane of the ambulance impacted the frontal plane of the Kenworth in an offset, head-on impact configuration. This impact resulted in severe deformation to the ambulance's frontal plane, and completely separated its left front tire/wheel assembly. As the vehicles crushed to maximum engagement, a counterclockwise (CCW) rotation was induced on the ambulance by the offset configuration of the impact with respect to the vehicles' respective masses. The point of impact and this CCW rotational movement was evidenced by tire and gouge marks at the scene (*refer to **Figure 4** above*), and the ambulance was deflected back toward its original southbound travel lane.

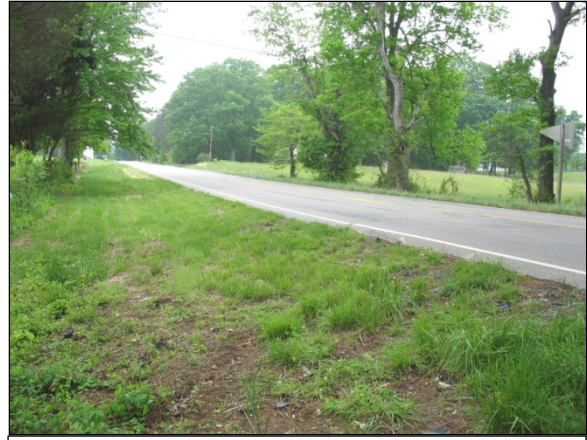
The ambulance rotated CCW and achieved a right side-leading orientation, which created an instability with respect to the vehicle's longitudinal central axis of gravity due to the increasing drag force load on the right side tires. These forces depressed the sidewall of the right front tire, which rolled the bead off the wheel rim and deflated the tire. The exposed outward edge of the wheel contacted the asphalt roadway surface. This contact resulted in abrasions to the wheel rim and a metallic gouge in the roadway surface, located approximately 4.5 m (14.8 ft) south of the initial point of impact. These dynamics instigated a trip-over into a right side-leading rollover (Event 2). The ambulance rolled one quarter-turn (right side-leading) over a distance of 5.3 m (17.4 ft), and departed the right roadway edge. The right plane contacted the soft grass/soil surface of the roadside swale area, resulting in minor right plane damage. The ambulance then slid a short distance to final rest within the negatively sloped swale area, 12.3 m (40.4 ft) south of the initial point of impact (**Figure 5**). At rest, the ambulance was positioned on its right plane, facing east.

Figure 5: Northeast lookback view from the ambulance's final rest position.

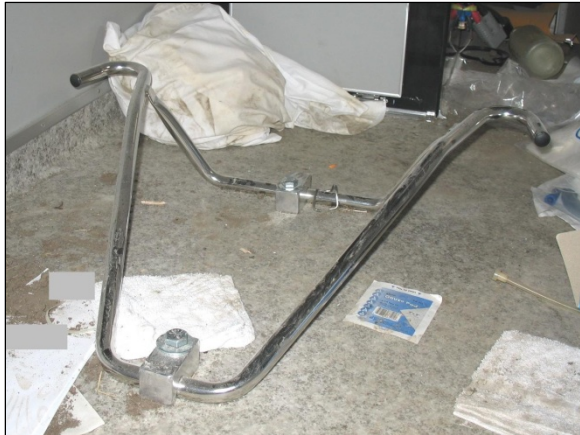
Figure 19: Forward antler bracket of the stretcher anchoring system within the Ford/Medix Type II ambulance.

As the rollover sequenced progressed, the displacement of the stretcher's rear aspect from the locking clamp mechanism disengaged the forward guide wheels and frame from the antler bracket. Subsequently, the entire stretcher was displaced toward the right roof side rail as the ambulance came to rest, contacting its displaced occupant and coming to rest on top of him. The stretcher itself sustained only minor damage during the crash sequence, consisting of only the slight angular deformation of the locking pin and frame rail at the pin's mount location. All adjustments and mechanical components were functional.

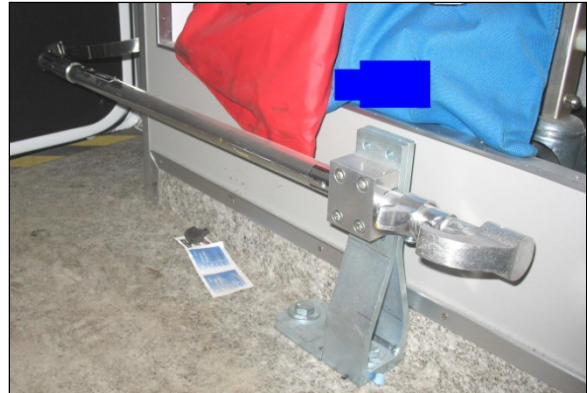
Figure 20: Locking-clamp mechanism of the stretcher anchoring system within the Ford/Medix Type II ambulance.

As the ambulance initiated its right side-leading rollover sequence, the force of gravity acting on the stretcher's mass induced the movement of the stretcher toward the ambulance's right plane. The locking pin departed the locking-clamp opening and the right aspect of the stretcher contacted the rear left-facing aspect of the bench seat base. This contact fractured the plywood structure and deformed the bench seat base 2 cm (0.8 in) laterally (**Figure 22**).
